**PRELIMINARY GEOLOGIC AND
GEOTECHNICAL ASSESSMENT**

SAN BRUNO A

**Glenview Drive and San Bruno Avenue
San Bruno, California**

Project No. K024.G

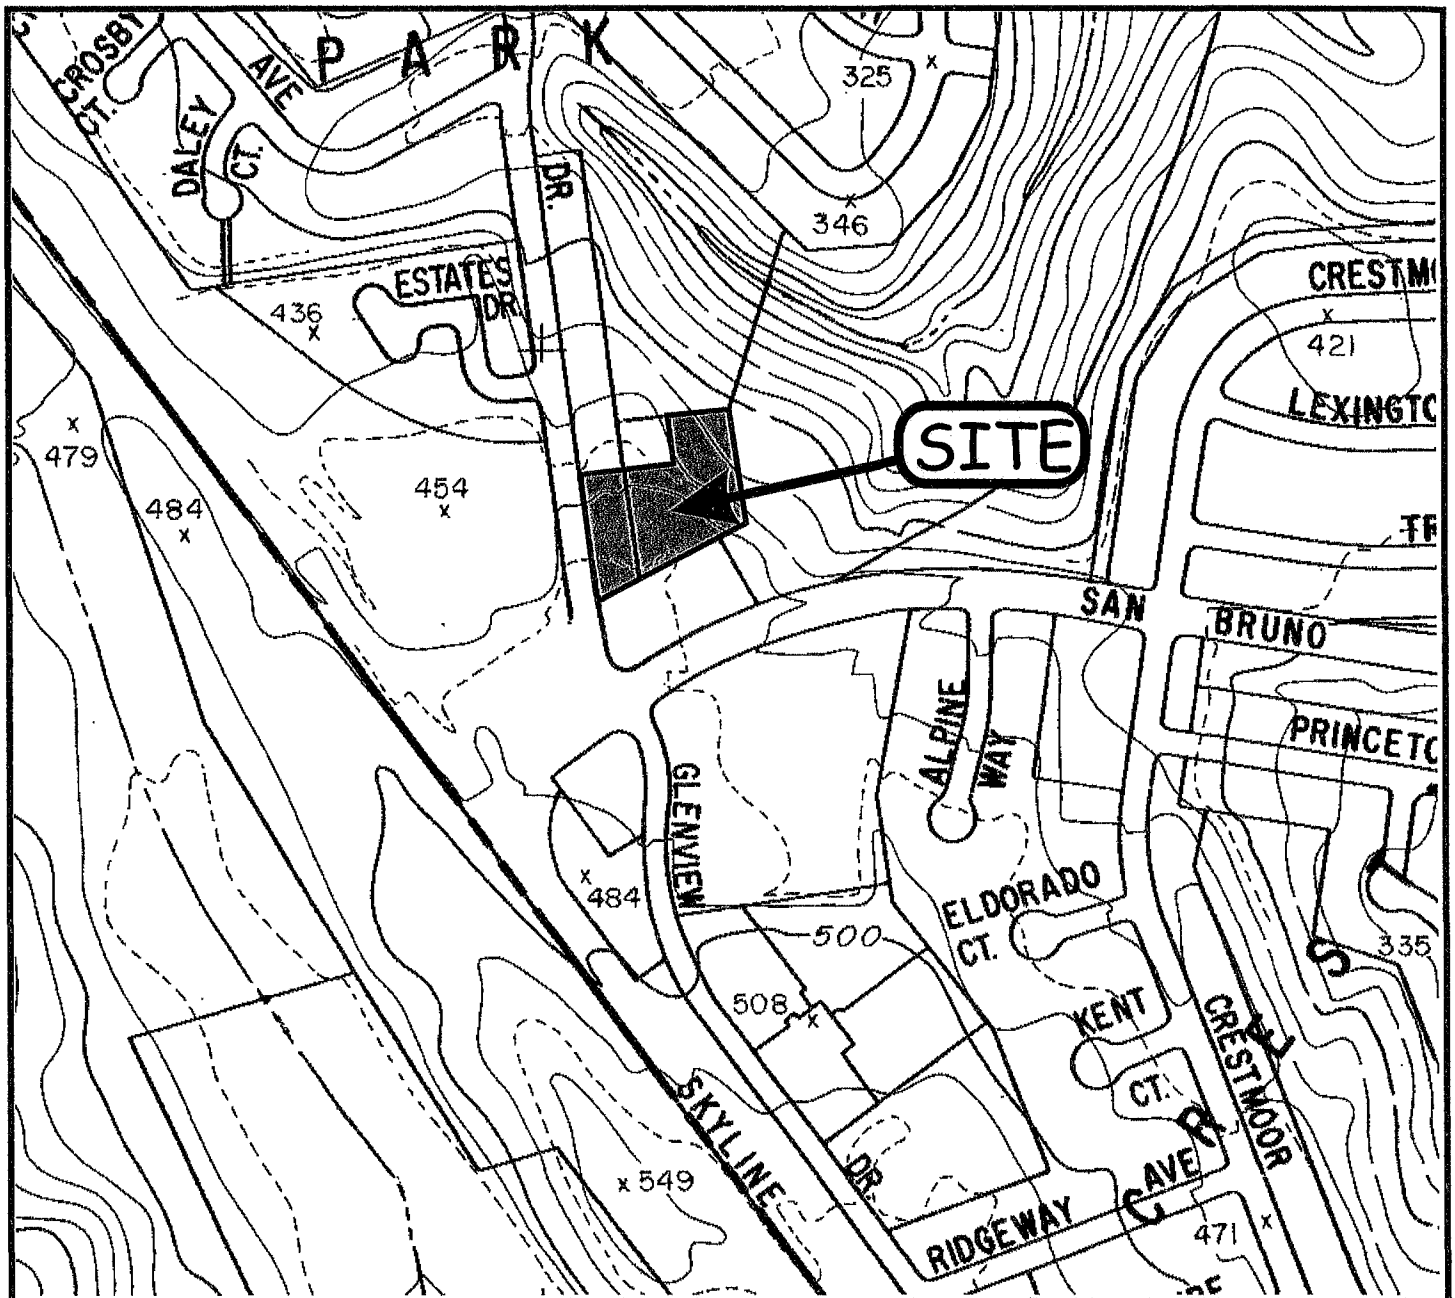
<p>Earth Investigations Consultants</p>	<p>Job No. 2271.01.00 Date 10/13/08</p>	<p>VICINITY MAP 850 Glenview Drive San Bruno, California</p>	<p>Plate 1</p>
--	--	--	--------------------------------

San Mateo County Topographic Map 5C (1/1/96)

Contour interval = 20'

This investigation was performed in the southern part of the Peace Lutheran Church property located at 850 Glenview Drive, San Bruno, California, near the intersection with San Bruno Avenue, in San Bruno, California (Plate 1, Vicinity Map, and Plate 2, Engineering Geologic Map and Generalized Cross Section A-A'), and within the eastern part of the State of California designated Earthquake Fault Zone (Plate 3, Earthquake Fault Zone Map).

The area of this investigation is characterized by a graded, relatively flat topographic surface bordered on the northeast by a steep, densely vegetated slope that drains to San Bruno Creek (Plates 1 and 2). This topography is a product of mass grading during the middle to late 1950's for improvement of San Bruno Avenue and Glenview Drive, and late 1950's to early middle 1960's for

development of the church facility. Historic aerial photographs indicate at least 20 feet of earth was removed from the dissected, linear ridgeline that originally characterized the site area (Plate 5). From the aerial photographs, it is apparent much of the investigation area is a cut surface with undocumented fill extending over the steep slope bordering the eastern side. This slope descends eastward approximately 150 vertical feet to San Bruno Creek (Plate 1).

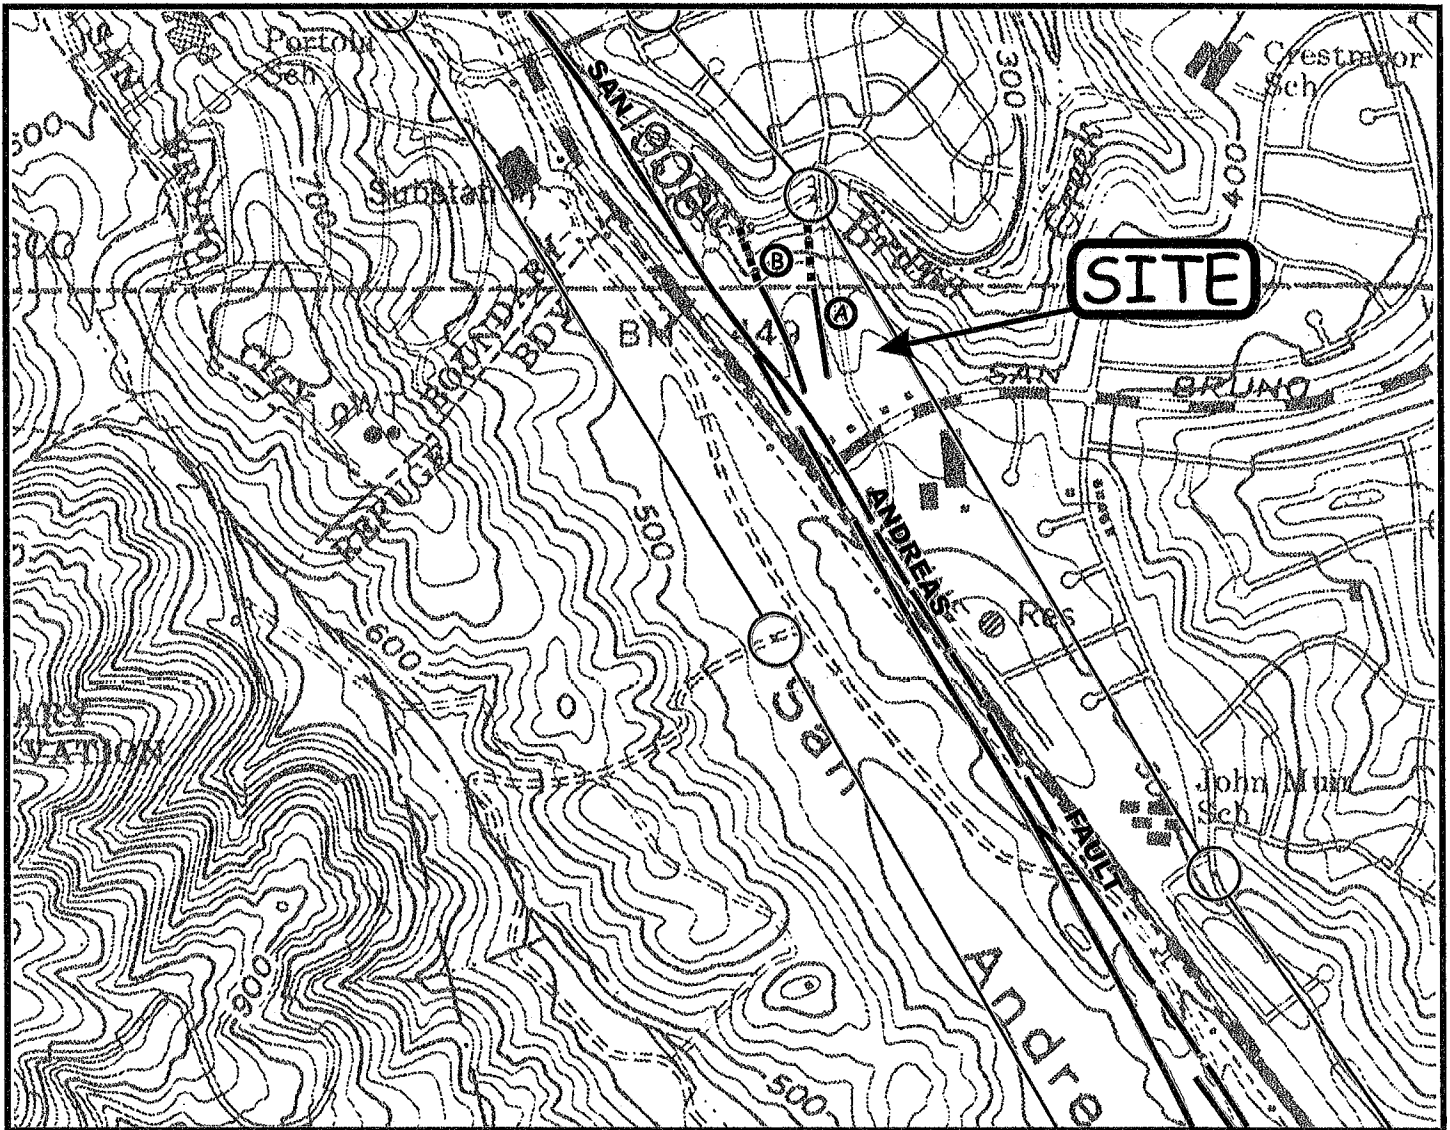
Earth Investigations Consultants	Job No. 2271.01.00	EARTHQUAKE FAULT ZONE MAP	Plate 3
	Date 10/13/08

These are delineated as straight-line segments that connect encircled turning points so as to define studies zone segment (CDMG; 1982)

After California Division of Mines and Geology (1982)

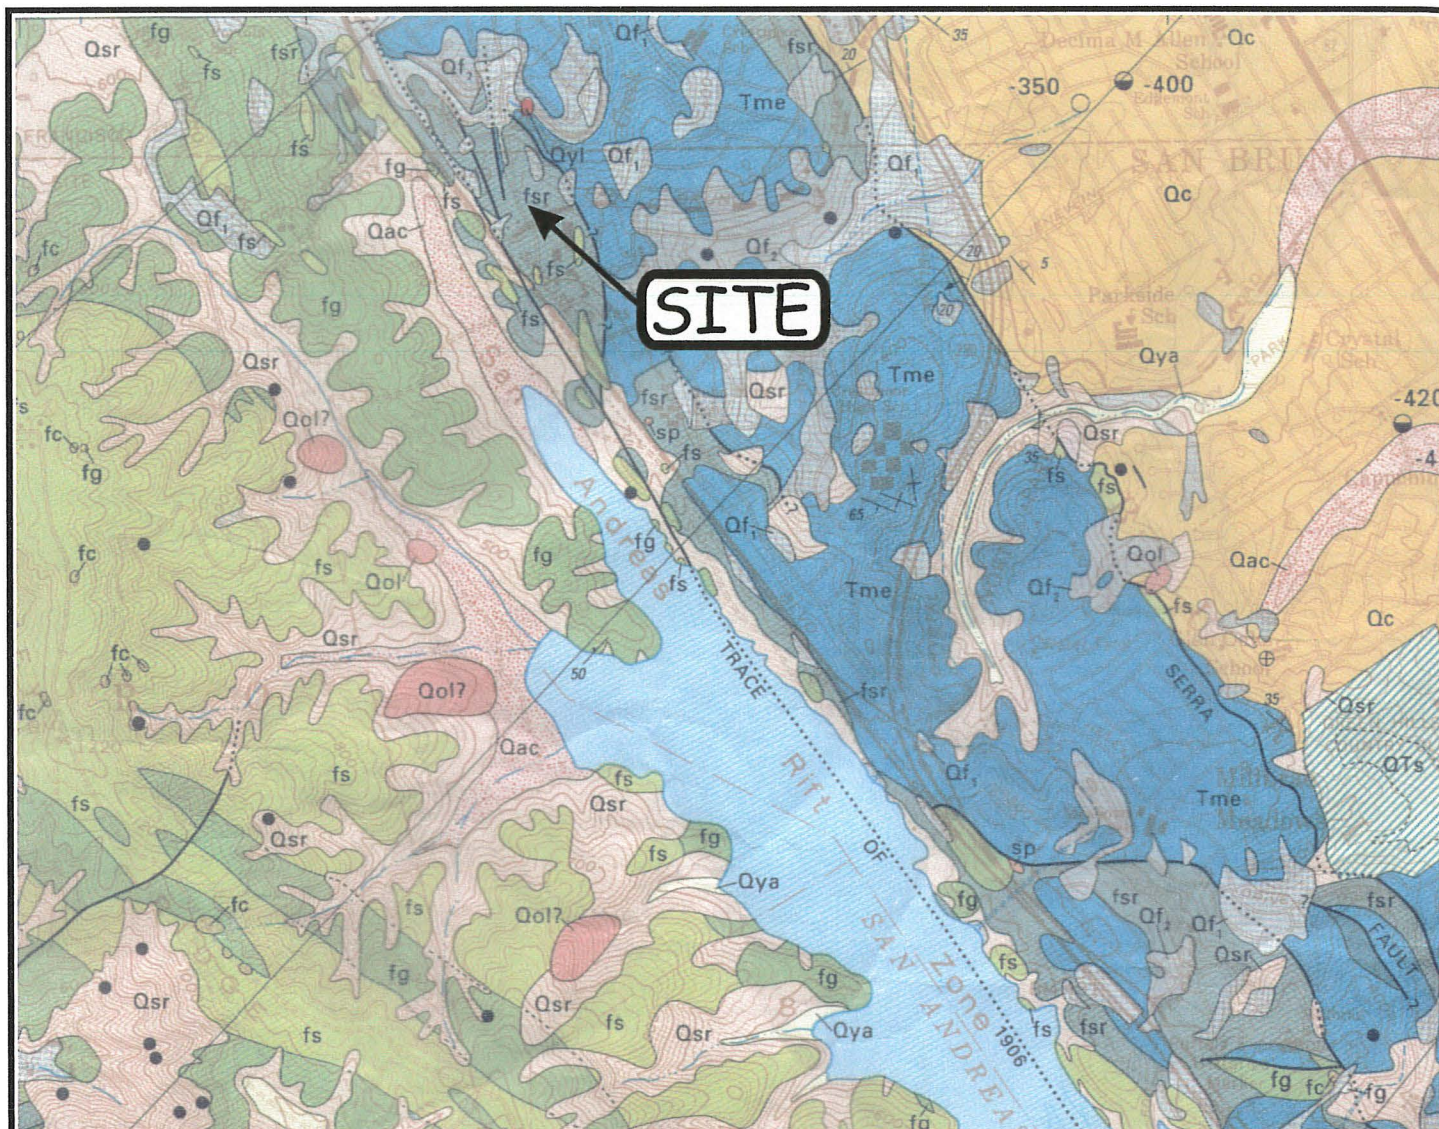
**Plate
4**

- — — — — Fault - dashed where inferred; dotted where concealed; queried where existence or extension is uncertain
- Shallow landslide, commonly in surficial material
- 65 Bedding attitude
- ⊥ Vertical
- 400 ◐ Borehole, showing altitude of basement rocks

GEOLOGIC MAP
850 Glenview Drive
San Bruno, California

- Review of pertinent geologic maps and reports pertaining to the site area. Plate 4, Geologic Map, depicts the site area geologic setting;
- Geomorphic interpretation of pertinent historic versions of the San Mateo, 15-minute topographic quadrangle (1899, 1915, 1942). Plate 5 (Historic Topographic Map) depicts site area geomorphic setting in 1915;

The site occupies the middle of a semi-circular body of Juro-Cretaceous Franciscan assemblage sheared rock bounded on the east by a curvilinear, inferred trace of the Serra fault, and on the west by the San Andreas fault zone (Leighton and Associates, 1976; Pampeyan, 1994; Plate 4). There are abundant exposures in road cuts between the site and Highway 92 to the southwest, which exhibit randomly and complexly distributed, often hard blocks (knockers) of ultramafic rock, including serpentinite and silica carbonate rock supported in a "matrix" of pulverized rock having the consistency of firm to stiff, usually plastic, gravelly and sandy clay and clayey sand. Pampeyan (1994) reports it is often referred to as *mélange*, as it occurs as several hundred feet of soft, light to dark gray sheared shale, siltstone, and greywacke with various-size tectonic inclusions of Franciscan rock, on the order of 100 million years old (Bailey and others, 1964).

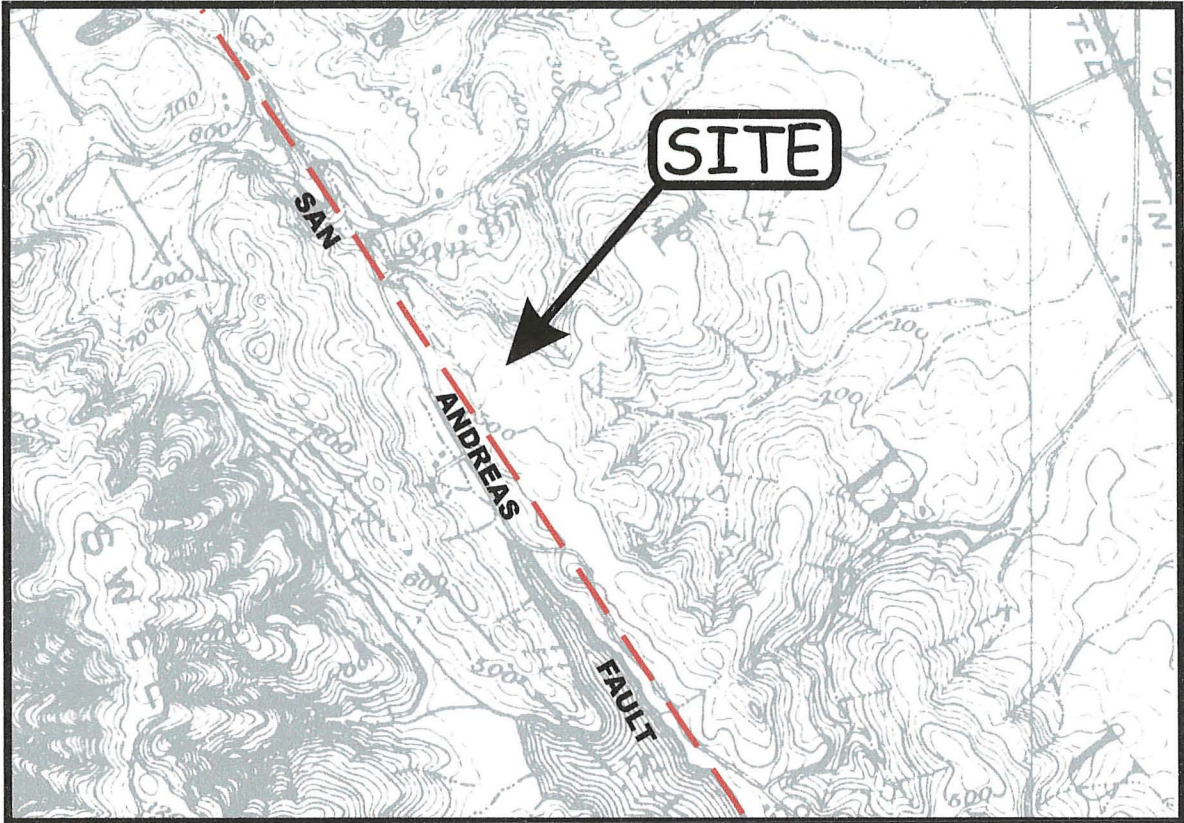
<p>Earth Investigations Consultants</p>	<p>Job No. 2271.01.00 Date 10/13/08</p>	<p>HISTORIC TOPOGRAPHIC MAP 850 Glenview Drive San Bruno, California</p>	<p>Plate 5</p>
--	---	---	---------------------------

Historic topographic map of site area from U. S. Geological Survey (1915 San Mateo, California 15-minute topographic quadrangle).

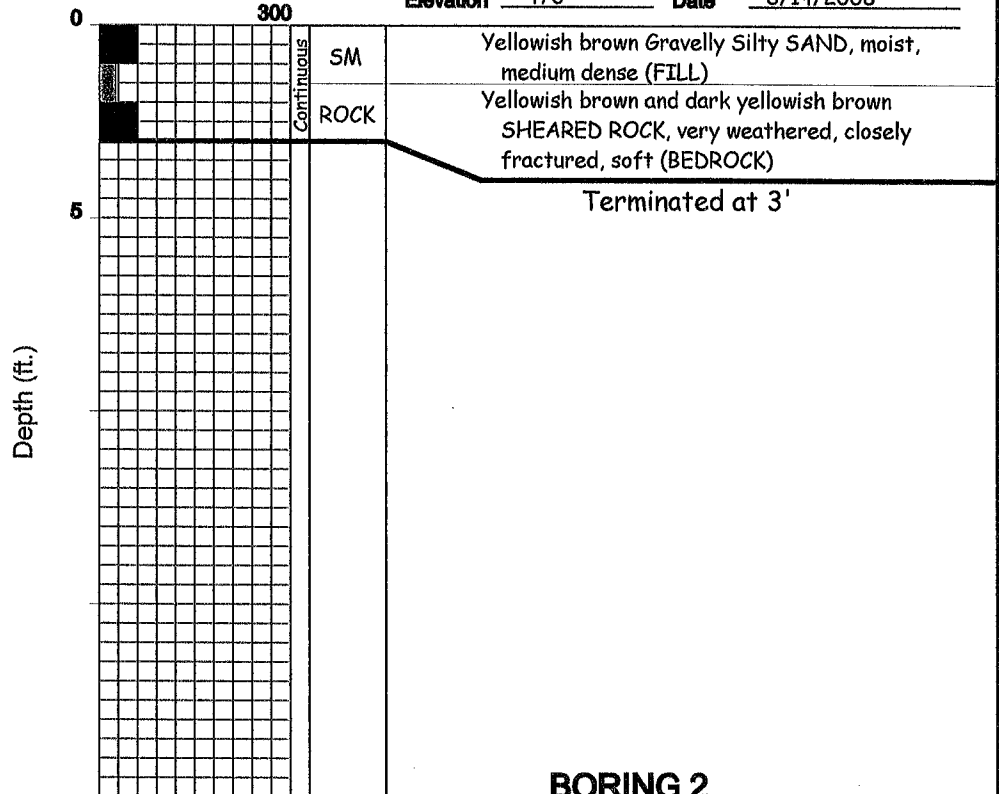
BORING 2

Elevation ~457' Date 8/14/2008

101.4 6.4
 107.2 9.1
 120.9 12.0
 112.5 9.1

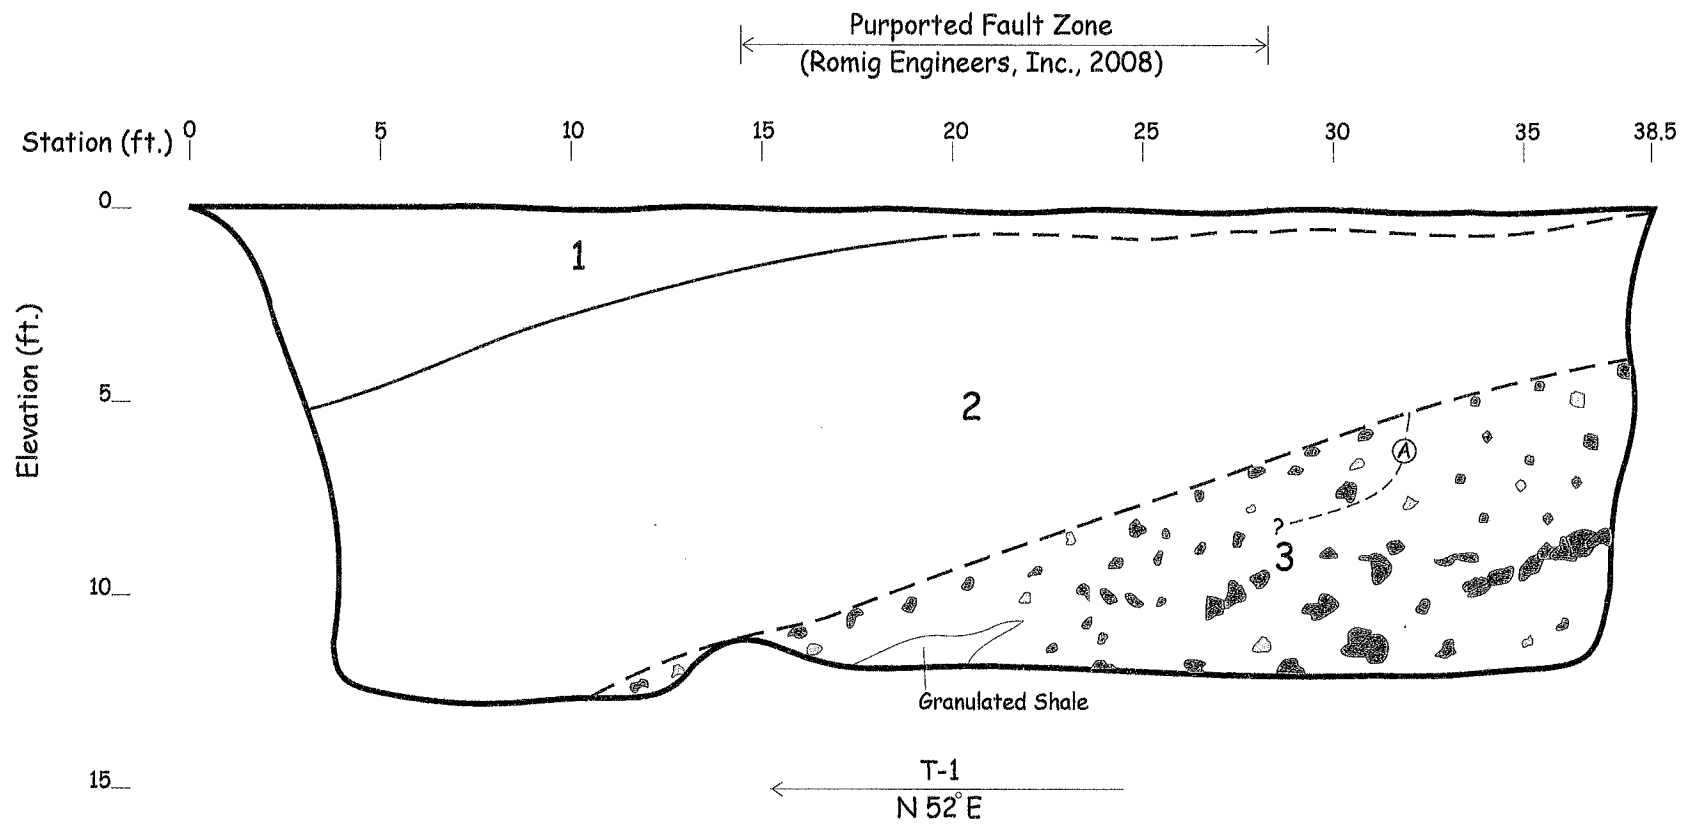
Earth Investigations Consultants	Job No. 2271.01.00	LOGS OF TRENCHES	850 Glenview Drive San Bruno, California	Plate A5
	Approved			
	Date 10/13/08

C. Approximately 1/8-inch wide, East-West trending, stiff, unsheared CLAY seam.

D. Approximately 6-inch wide seam of dark olive green, stiff, unsheared fine to coarse, Sandy CLAY exhibiting cross-trench orientation of approximately North 25 degrees West.

The sheared rock was overlain by approximately 10 feet of massive, dark brown to dark grayish brown, very stiff to hard, clayey, gravelly, silty sand, colluvium containing angular to subrounded clasts of moderately hard to hard serpentinite, silica-carbonate rock and sandstone. It was dark brown and slightly moist in the upper 1 feet grading to dark yellowish brown and moist below. The inferred, areal distribution of colluvium is depicted on Plate 2. A detailed description of this unit and rationale for an age assignment of 130,000 years is contained in Appendix B.

A wedge of undocumented fill from historic grading activity was encountered in the eastern third of the exposure. It consisted of slightly moist clayey, silty sand with occasional concrete debris.

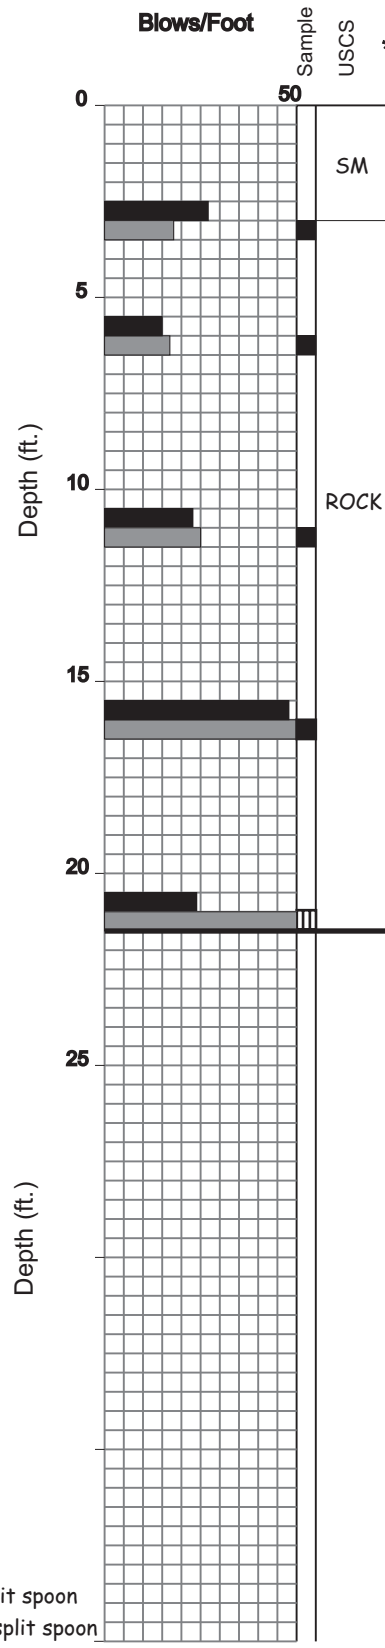
* Elevation ~340' Date 2/2/05

SM
Dark yellowish brown Gravelly Silty SAND, damp, medium dense (FILL)

ROCK
Dark yellowish brown, dark brown and dark grey SHEARED ROCK, damp, very weathered, closely fractured, soft to moderately hard (BEDROCK)

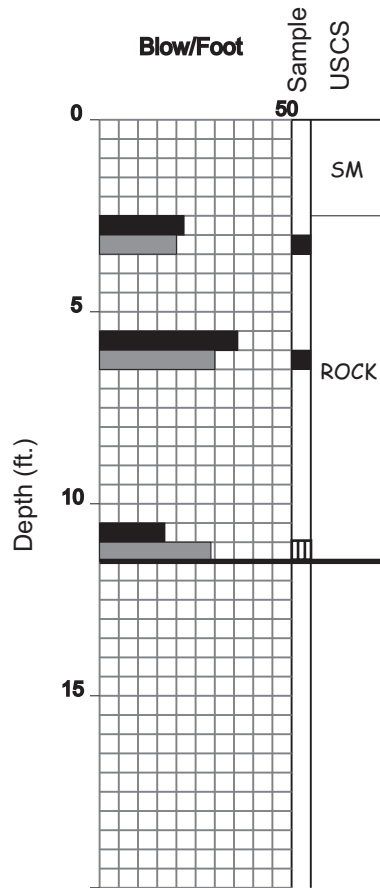
BORING 4

Equipment Truck Mounted CME-75 Auger
***Elevation** ~342' **Date** 2/2/2005

Dark yellowish brown Gravelly Silty SAND, damp, medium dense (FILL)
 Dark yellowish brown, GREENSTONE, very weathered, closely fractured, soft to moderately hard (BEDROCK)

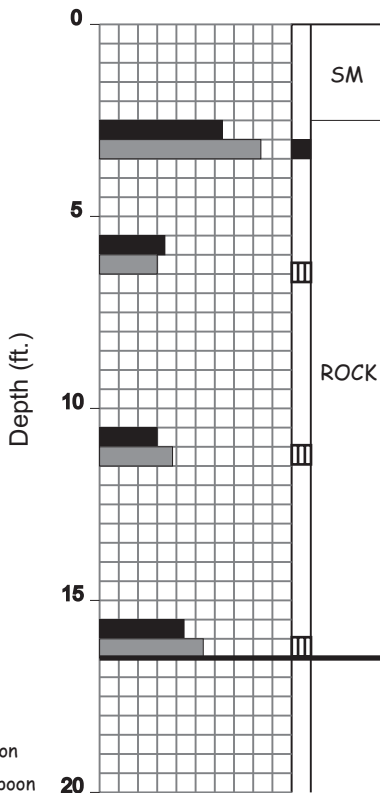
BORING 5

125.4 7.3 74
 113.2 8.4 34
 126.5 10.0 49

***Elevation** ~341' **Date** 2/2/2005

Dark yellowish brown Gravelly Silty SAND, damp, medium dense (FILL)
 Dark yellowish brown GREENSTONE, very weathered, closely fractured, soft to moderately hard (BEDROCK)
 No recovery

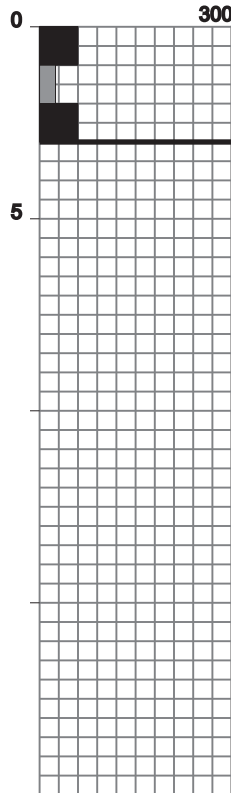
BORING 1 (Soil Probes)

Elevation★ ~470' Date 8/14/2008

Continuous
SM
ROCK

Yellowish brown Gravelly, Silty SAND, moist, medium dense (FILL)
Yellowish brown and dark yellowish brown SHEARED ROCK, very weathered, closely fractured, soft (FRANCISCAN ASSEMBLAGE)

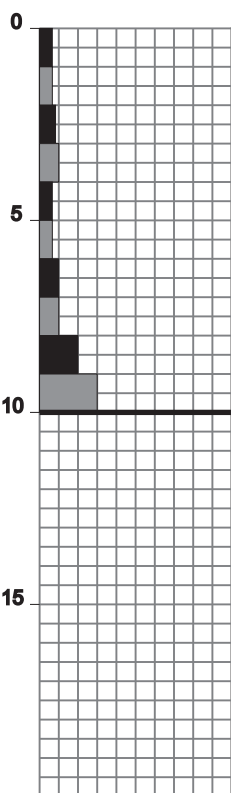
BORING 2 (Soil Probes)

Elevation★ ~457' Date 8/14/2008

Continuous
SC
SC
ROCK

Yellowish brown and dark yellowish brown Gravelly, Clayey SAND, moist, medium dense (FILL)

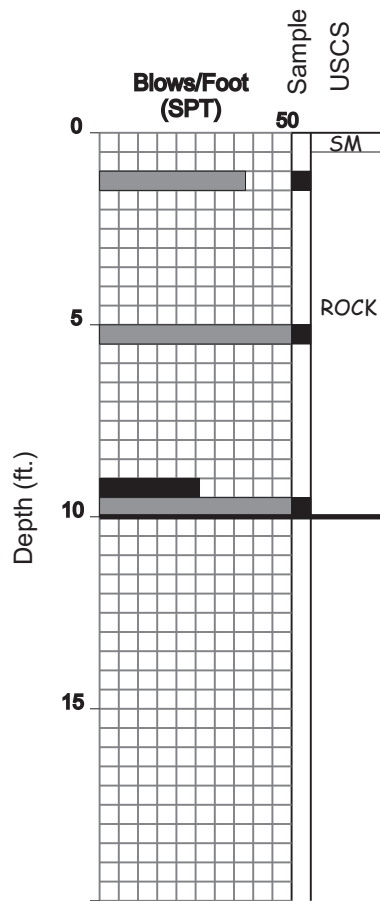
Equipment Truck-Mounted Flight Auger
Elevation \star ~466' Date 6/25/2013

Yellowish brown Silty SAND, moist, medium dense (FILL)
Yellowish brown and dark yellowish brown SHEARED ROCK, very weathered, closely fractured, soft to moderately hard (FRANCISCAN ASSEMBLAGE)

Terminated at 10'

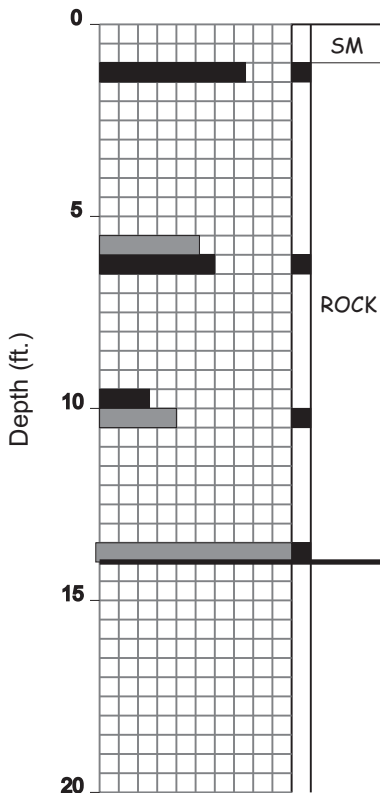
BORING 5

Elevation \star ~467" Date 6/25/2013

Yellowish brown Gravelly, Silty SAND, moist, medium dense (FILL)
Dark yellowish brown and dark grey SHEARED ROCK, very weathered, closely fractured, soft to moderately hard (FRANCISCAN ASSEMBLAGE)

Terminated at 13' 11"

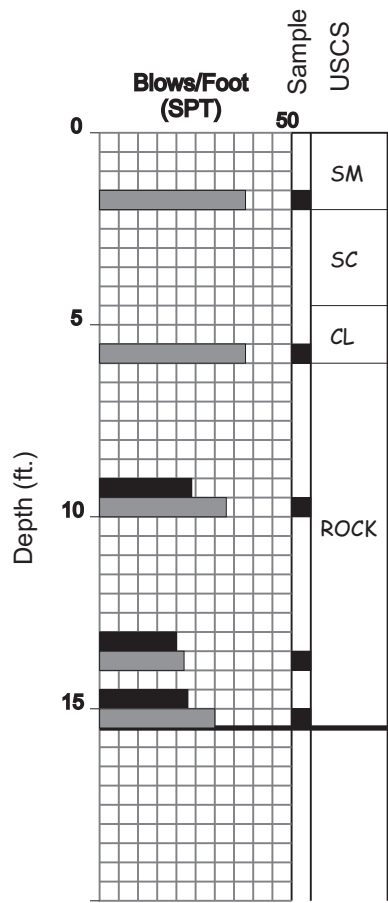
BORING 6

Dry Density (pcf)	Moisture Content (%)	Blows/Foot (SPT)
111.4	9.3	38/3"
122.9	11.4	38/3"
108.2	14.3	57
121.6	9.7	53

Equipment Truck-Mounted Flight Auger
 Elevation \star ~463' Date 6/25/2013

0
Brown Gravelly Silty SAND, moist, very dense (FILL)

5
Dark yellowish brown Clayey SAND with Gravel, moist, very dense (COLLUVIUM)

15
Dark yellowish brown and greyish brown SHEARED ROCK, very weathered, closely fractured, soft (FRANCISCAN ASSEMBLAGE)

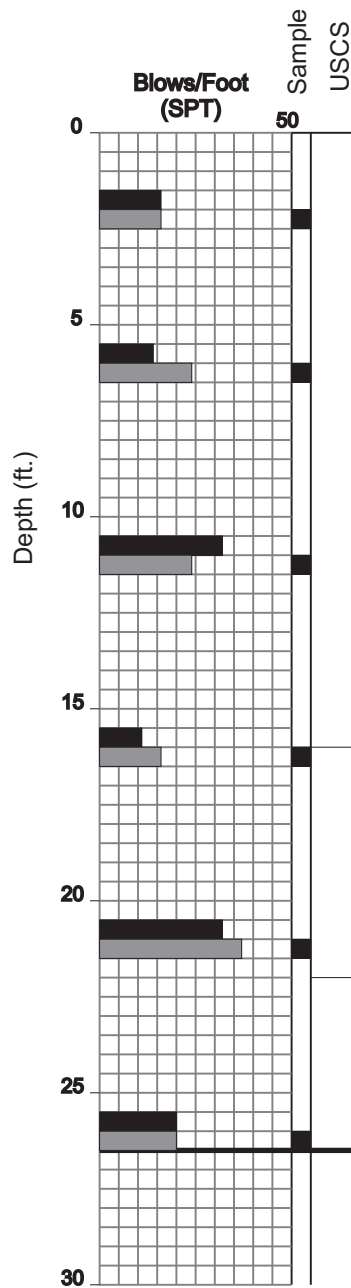
Elevation \star ~457' **Date** 6/25/2013

Brown Silty SAND with Gravel, moist, dense (FILL)

color changes to dark yellowish brown, grades to Gravelly Silty SAND with Clay

Dark grey SHEARED ROCK, very weathered, closely fractured, soft (FRANCISCAN ASSEMBLAGE)

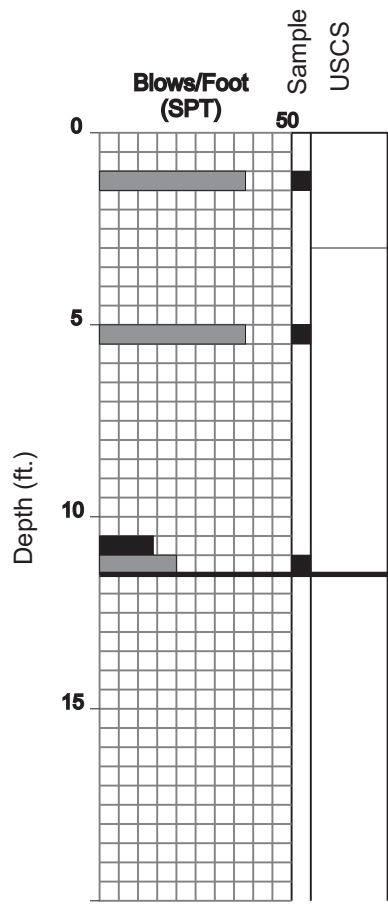
Equipment Truck-Mounted Flight Auger
Elevation \star ~461' **Date** 6/25/2013

Yellowish brown Gravelly Silty SAND, moist, very dense (FILL)

Yellowish brown SANDSTONE, very weathered, closely fractured, hard (FRANCISCAN ASSEMBLAGE)

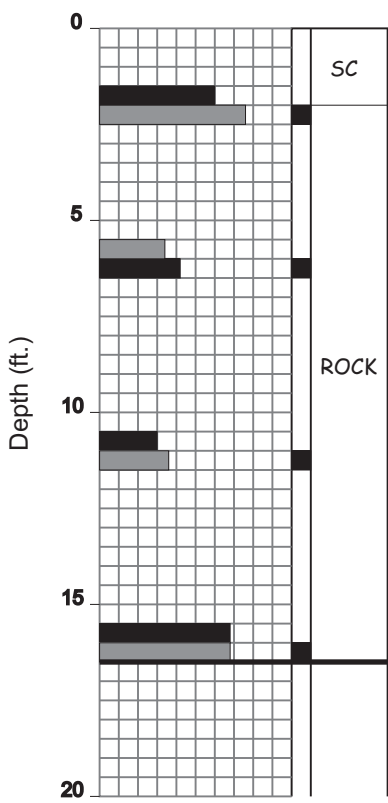
Elevation \star ~441" **Date** 6/25/2013

Dark yellowish brown Clayey SAND with Gravel, moist, very dense (FILL)

Dark yellowish brown and dark grey SHEARED ROCK, very weathered, closely fractured, soft (FRANCISCAN ASSEMBLAGE)

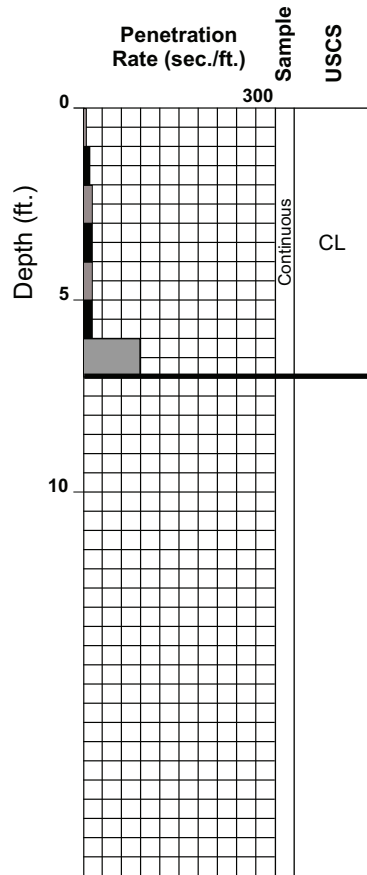
BORING 3 (Soil Probe)

Dry Density (pcf) 124.5
 Moisture Content (%) 8.8
 Pocket Pen (tsf) >4.5

Equipment Portable Percussion Rig
 Elevation ~465' Date 01/15/16

Yellow brown Sandy CLAY with Gravel, damp, firm (FILL?)
 color changes to yellow brown & dark yellow brown @ 2 1/2'

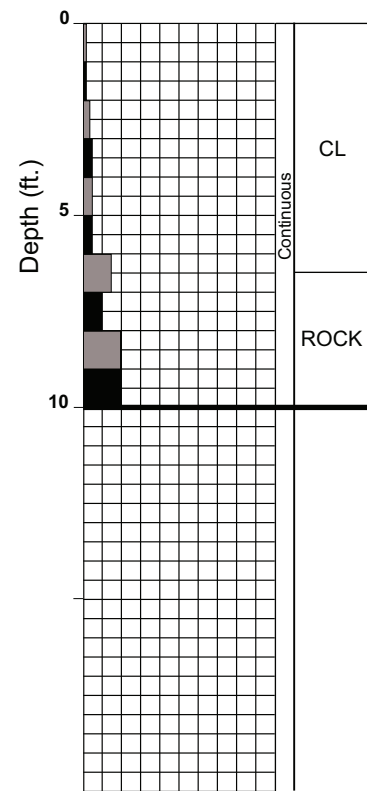
BORING 4 (Soil Probe)

Dry Density (pcf) 105.2
 Moisture Content (%) 22.4
 Pocket Pen (tsf) 3.0, >4.5, >4.5

Elevation ~465' Date 01/15/16

Yellow brown, dark yellow brown and grey Sandy CLAY with Gravel, damp, firm (FILL?)

Dark brown SHEARED ROCK very weathered, closely fractured, soft

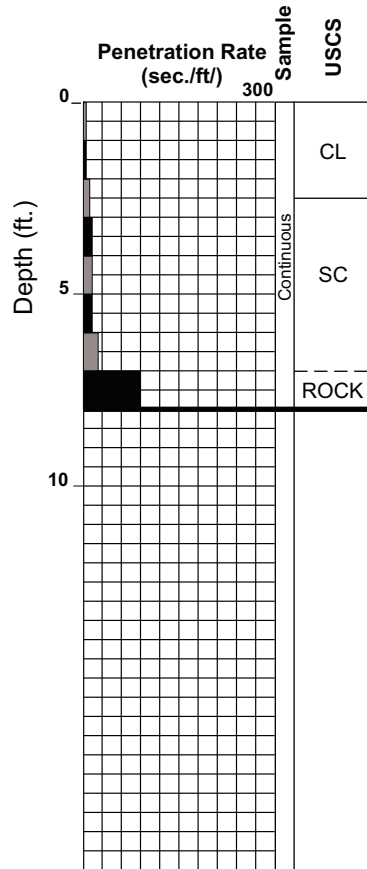
Equipment Portable Percussion Rig
Elevation ~465' Date 01/15/16

Dark yellow brown Gravelly Sandy CLAY, damp, firm (FILL)
CL
Yellow brown Gravelly Clayey SAND, moist, medium-dense (FILL?)
SC
Yellow brown SHEARED ROCK(?) very weathered, closely fractured, moderately hard
ROCK

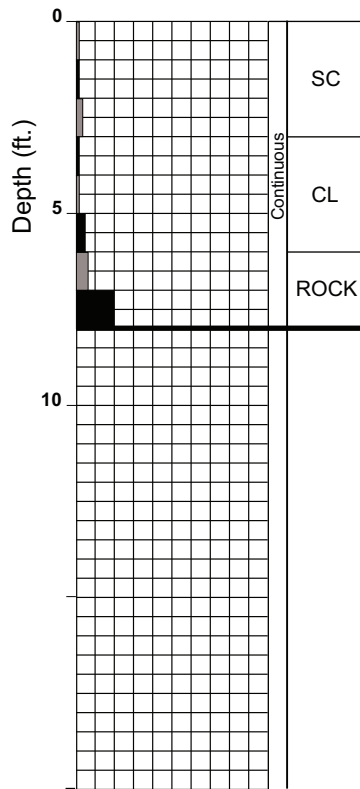
85.5 22.7
115.0 16.1
112.4 15.2
1.0

Elevation ~465' Date 01/15/16

Yellow brown Gravelly Clayey SAND, damp, loose to medium dense (FILL)
SC
Dark yellow brown Sandy CLAY, damp, firm (COLLUVIUM)
CL
Dark yellow brown SHEARED ROCK(?) very weathered, closely fractured, soft
ROCK

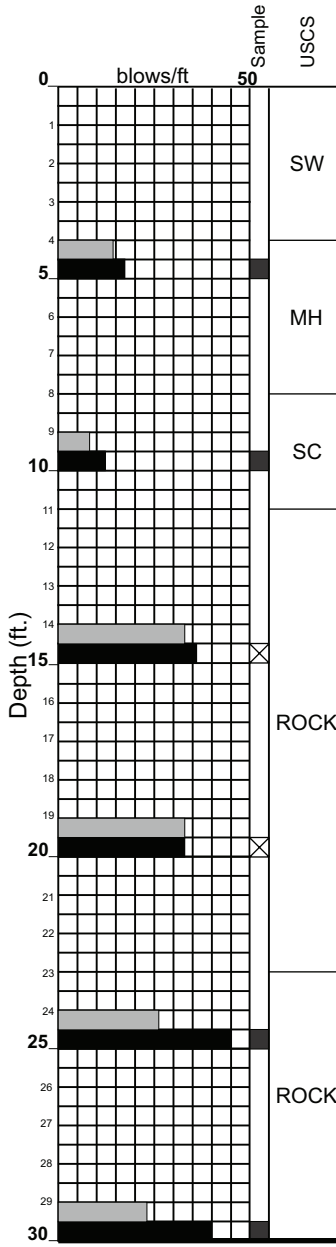
Elevation ~465 ft. Date 12/06/19

-200 Sieve (%)	Dry Density (pcf)	Moisture Content %	Blows/Foot (SPT)
54.3	81.7	40.6	31
33.4	110.8	6.9	20
70			
66			
19.4	126.4	9.7	70
63

SW	2½" AC/Grayish brown Gravelly SAND (Baserock) sewer pipe @ 3'
MH	Yellow brown & dark yellow brow Sandy CLAY with Gravel, damp stiff (FILL)
SC	Dark yellow brown Sandy CLAY with Gravel, damp, very stiff (COLLUVIUM)
ROCK	Yellow brown SANDSTONE, very weathered, closely fractured, moderately hard hard
ROCK	Yellow brown Sandy CLAYSTONE very weathered, closely fractured, moderately hard

Terminated @ 30'
